Naust

– the boathouses of Nyköping and the echoes of power

Tomas Westberg

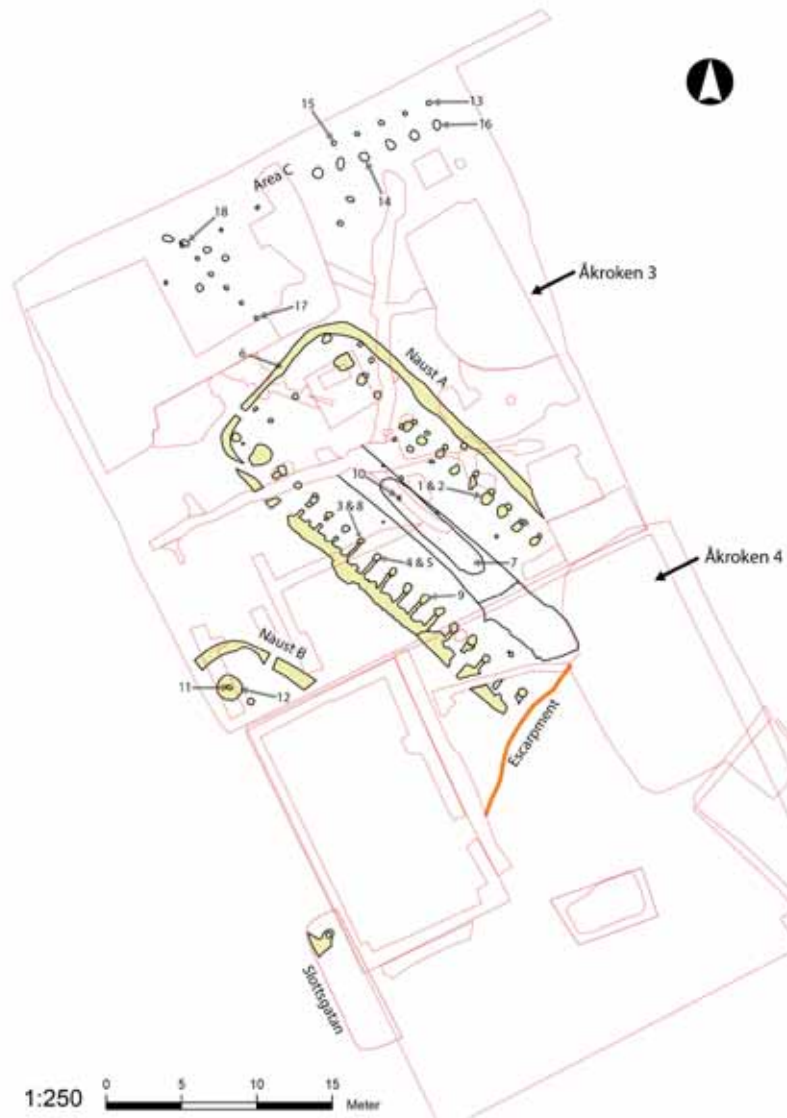
Fig. 1. Overview. Opaque lines represent excavation areas, disturbances, test trenches and modern buildings. The numbers display features sampled for radiocarbon dating (cf. tab. 1). Graufelds & Westberg 2013.

An additional area with clusters of postholes (henceforth Area C, fig. 1), contemporary with naust A, was encountered in the north and northeast corner of Åkroken 3 and is consequently included in the discussion.

Additional solitary postholes were encountered just inside the corners of the enclosing trench in the northwest in naust A on each side (fig. 1, 2). These have been interpreted as constituting additional support for the gable but can also have functioned as anchoring for a construction of some sort of larger doors or gateway (cf. fig. 3, 4). No postholes or other features that could constitute wall constructions for solid or closed short sides were found, which proves that they were free from grounded constructions. However, with regards to the fact that the drainage trench was intact in this section of both buildings, some sort of overhang probably ex-

Table 1. Radiocarbon dating. Cf. fig 1 for sampled features.

The second unit, consisting of five somewhat larger postholes, ran in a direction from west-northwest to east-southeast and had the shape of a backward L (fig. 1). The functions of these constructions are somewhat unclear. It is however apparent that it is not a question of buildings per se (except perhaps the first one). They are merely included in this discussion since they are contempora-

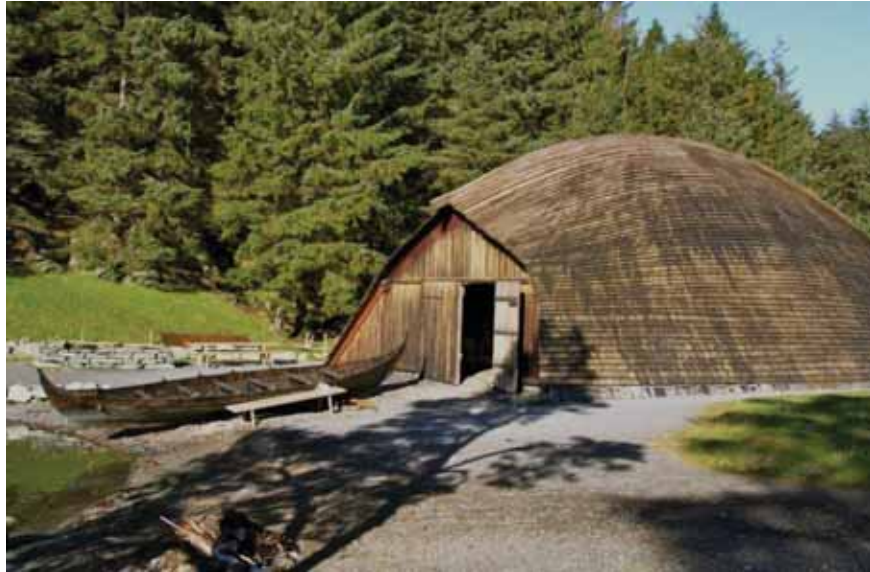
Figure 4. Reconstructed naust at Avaldsnes, Nordvegen Historiesenter. Used with permission.

As mentioned above, it is unlikely that the structures did not have closed surrounding walls (excepting the side facing the water). One possibility is that the roof was conjoined with the wall construction, following the angle and fastened to the supposed buttress-like/support post construction down towards the ground, albeit placing the drainage-trench on the outer side of the buildings (possibly similar to the reconstructed naust at Avaldsnes, fig. 4).
