# Naust

– the boathouses of Nyköping and the echoes of power

*Tomas Westberg*

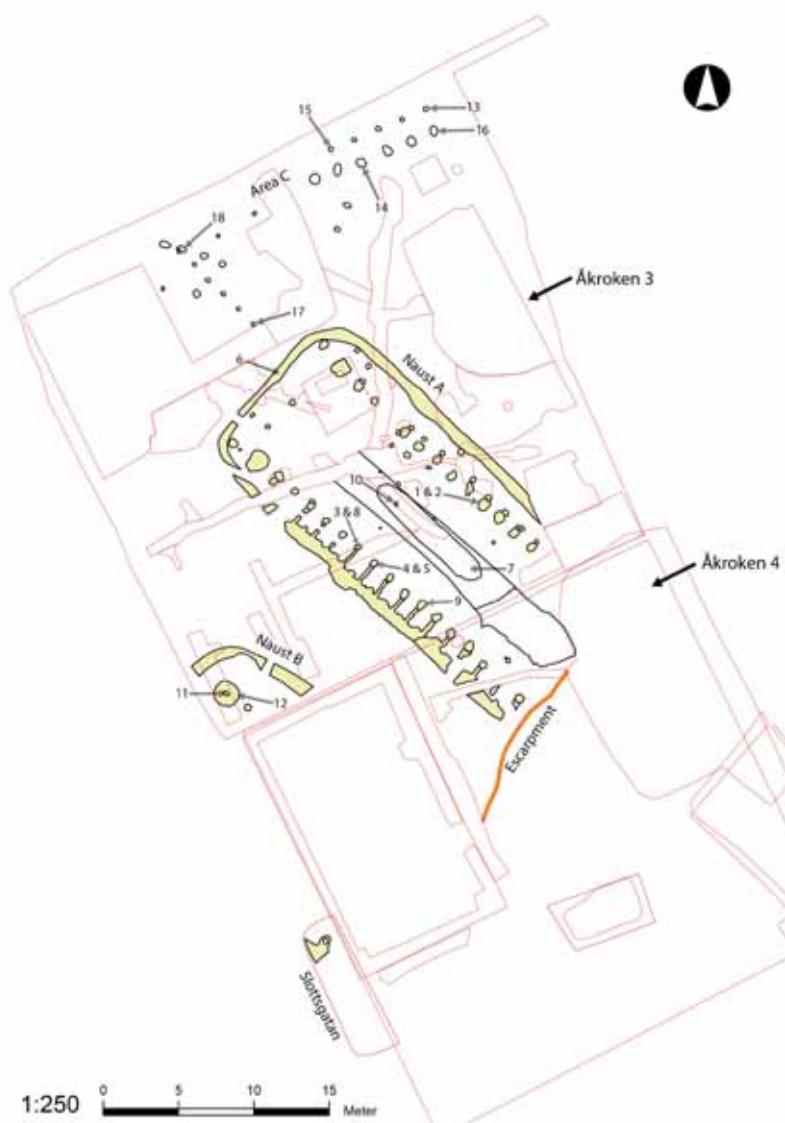
Fig. 1. Overview. Opaque lines represent excavation areas, disturbances, test trenches and modern buildings. The numbers display features sampled for radiocarbon dating (cf. tab. 1). Graufelds & Westberg 2013.

An additional area with clusters of postholes (henceforth Area C, fig. 1), contemporary with naust A, was encountered in the north and northeast corner of Åkroken 3 and is consequently included in the discussion.

Additional solitary postholes were encountered just inside the corners of the enclosing trench in the northwest in naust A on each side (fig. 1, 2). These have been interpreted as constituting additional support for the gable but can also have functioned as anchoring for a construction of some sort of larger doors or gateway (cf. fig. 3, 4). No postholes or other features that could constitute wall constructions for solid or closed short sides were found, which proves that they were free from grounded constructions. However, with regards to the fact that the drainage trench was intact in this section of both buildings, some sort of overhang probably ex-

The second unit, consisting of five somewhat larger postholes, ran in a direction from west-northwest to east-southeast and had the shape of a backward L (fig. 1). The functions of these constructions are somewhat unclear. It is however apparent that it is not a question of buildings per se (except perhaps the first one). They are merely included in this discussion since they are contemporaneous.

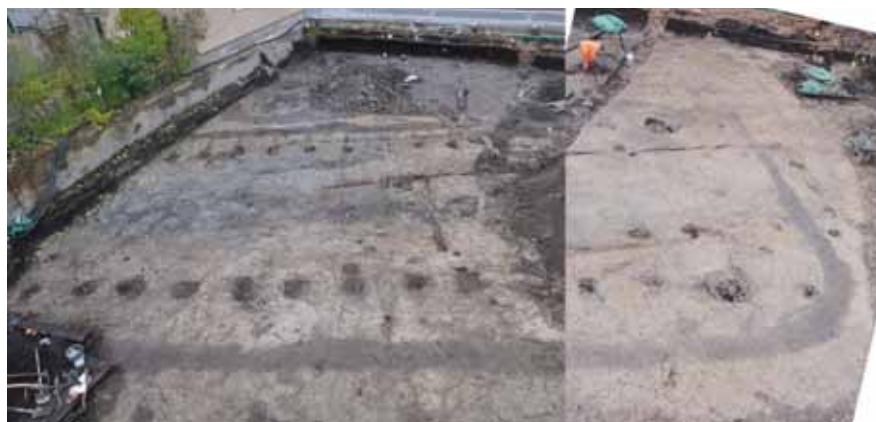
Figure 2. Merged photographs of naust A. The building was excavated in two sections in Åkroken 3 due to dump-management. The southeastern part of the building was situated underneath the wall to the left in the picture within Åkroken 4. Photo from the northeast. 2010 RAÄ Uv Mitt.

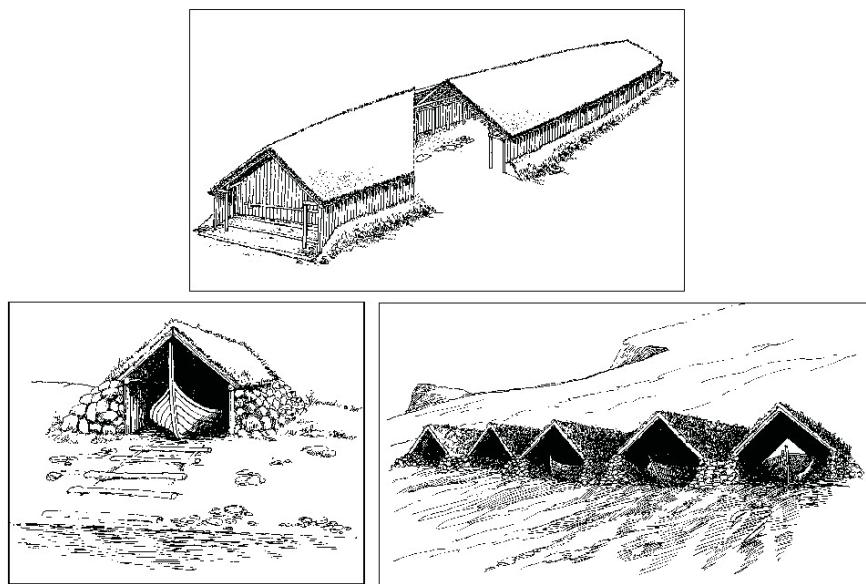
Figure 3. From Stylegar & Grimm 2005, with permission. Note especially the top building.

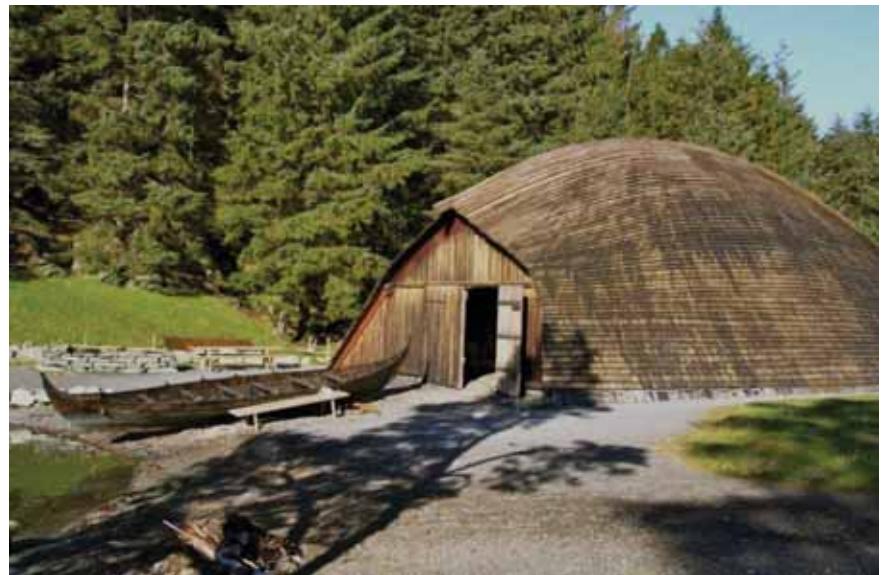
Figure 4. Reconstructed naust at Avaldsnes, Nordvegen Historiesenter. Used with permission.

As mentioned above, it is unlikely that the structures did not have closed surrounding walls (excepting the side facing the water). One possibility is that the roof was conjoined with the wall construction, following the angle and fastened to the supposed buttress-like/support post construction down towards the ground, albeit placing the drainage-trench on the outer side of the buildings (possibly similar to the reconstructed naust at Avaldsnes, fig. 4).
