Naust

– the boathouses of Nyköping and the echoes of power

Tomas Westberg

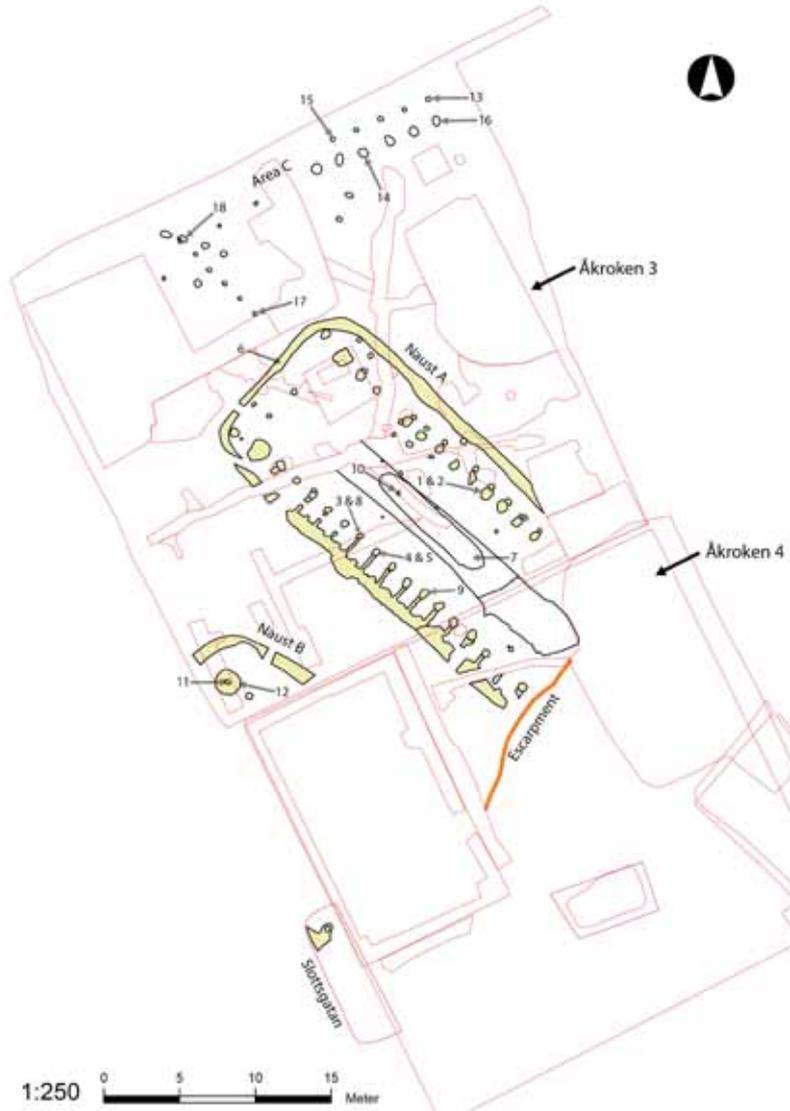
Fig. 1. Overview. Opaque lines represent excavation areas, disturbances, test trenches and modern buildings. The numbers display features sampled for radiocarbon dating (cf. tab. 1). Graufelds & Westberg 2013.

An additional area with clusters of postholes (henceforth Area C, fig. 1), contemporary with naust A, was encountered in the north and northeast corner of Åkroken 3 and is consequently included in the discussion.

Additional solitary postholes were encountered just inside the corners of the enclosing trench in the northwest in naust A on each side (fig. 1, 2). These have been interpreted as constituting additional support for the gable but can also have functioned as anchoring for a construction of some sort of larger doors or gateway (cf. fig. 3, 4). No postholes or other features that could constitute wall constructions for solid or closed short sides were found, which proves that they were free from grounded constructions. However, with regards to the fact that the drainage trench was intact in this section of both buildings, some sort of overhang probably ex-

Table 1. Radiocarbon dating. Cf. fig 1 for sampled features.

The second unit, consisting of five somewhat larger postholes, ran in a direction from west-northwest to east-southeast and had the shape of a backward L (fig. 1). The functions of these constructions are somewhat unclear. It is however apparent that it is not a question of buildings per se (except perhaps the first one). They are merely included in this discussion since they are contempora-

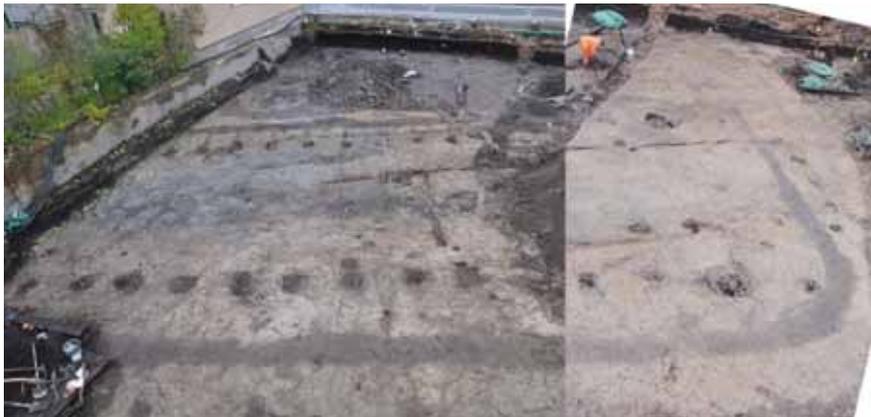
Figure 2. Merged photographs of naust A. The building was excavated in two sections in Åkroken 3 due to dump-management. The southeastern part of the building was situated underneath the wall to the left in the picture within Åkroken 4. Photo from the northeast. 2010 RAÄ Uv Mitt.
