# Trade and use of building lime

- early 19<sup>th</sup>-century lime barrels from an excavation in  
Uddevalla, Bohuslän

*Niklas Ytterberg & Kristin Balksten*

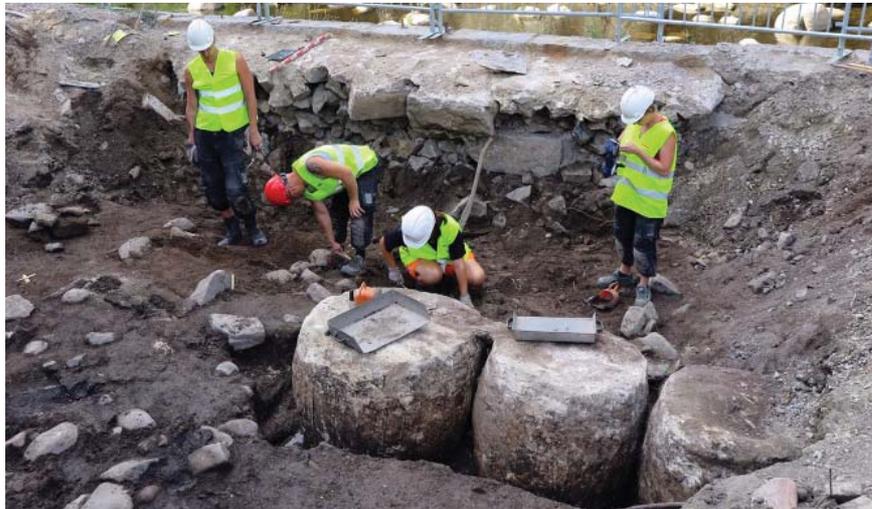
Figure 3a. Photo of the lime barrels (from the left) 4, 3 and 2, which were excavated during the summer of 2014. They have differing sizes but seem to hold similar lime putties. Photo: Kristin Balksten.

In order to gain a better understanding of how the lime putty was prepared and treated, a more detailed description of the barrels is required. The biggest barrel, to the north-west, measured 1.15 m in maximum width, and the second biggest, at the end of the row to the south-east, measured around 1 m. The two barrels in the middle were slightly smaller, c. 0.8 m. The height differed from c. 0.8 to 1 m, making the barrels a bit wider than they were high. The barrels were bulged slightly in the middle, as usual. The staves were very poorly preserved. Impressions of the staves in the lime putty revealed an individual width of 0.10 - 0.15 m (4 to 6 inches) and a thickness of about 25 mm (1 inch). Preserved fragments of hoops indicate that they appear to be made of birch, whereas the bases of the barrels are made of pine. No head or lids are preserved, but these may very well never have been present. Three of the barrels contained a more greyish, lumpy lime and one barrel a distinctly white, creamy lime. We saw quite a lot of lime lumps in the pit, especially in the top fill close to the barrels' mouths. A probable explanation for this is that quicklime spilled over in the process of tipping it from smaller barrels to these ground-fixed barrels.

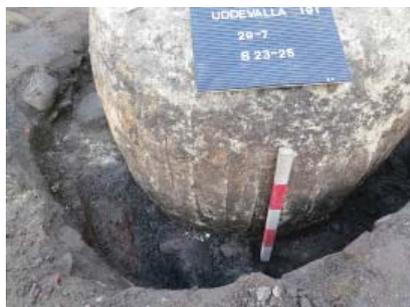
Figure 3b. Close-up of lime barrel 3 with the individual birch staves clearly visible. Photo: Niklas Ytterberg.

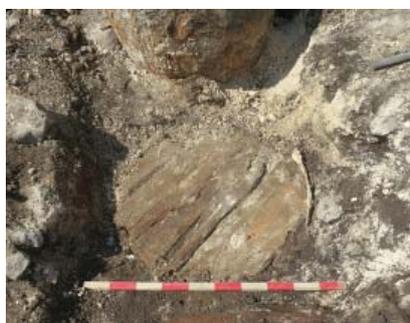
Figure 3c. Photo of the base of barrel 4, made of pine. Photo: Veronica Forsblom Ljungdahl.

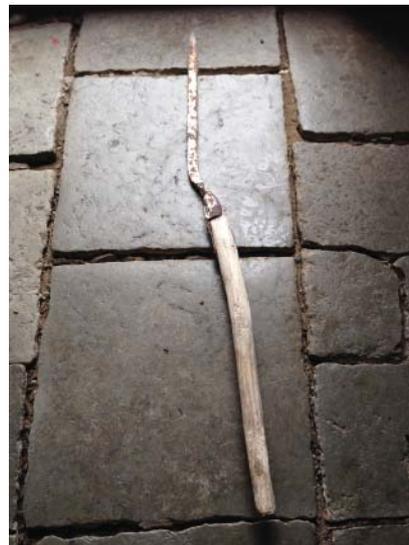
Figure 4. Lime whip from Svenneby old church. Photo: Kristin Balksten.

be recognized by the specific lime lumps in historic mortars (Balksten 2010). To be able to use earth slaked lime as a binder it must first be beaten with a lime whip (Siöbladh & Engeström 1750; Hidemark & Holmström 1984, p. 12pp).

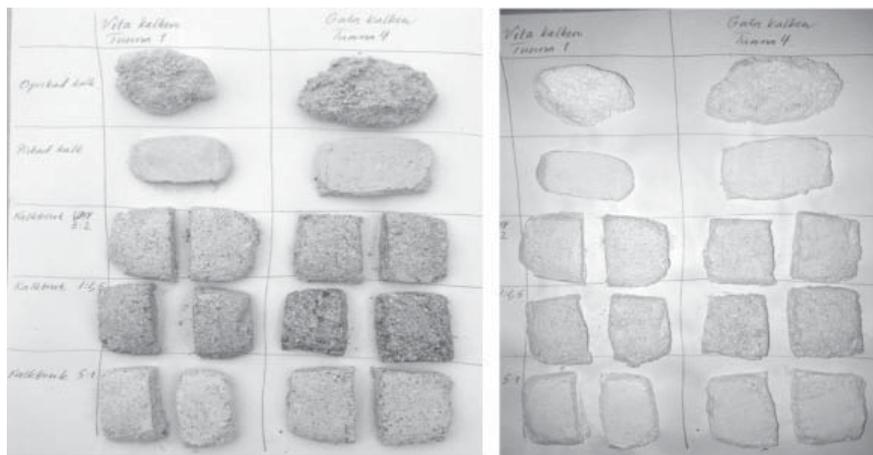
Figure 5. The experimental samples when they are fresh (to the left) and after two weeks (to the right), when they have been dried white. The samples that seemed very lean as fresh appeared more lime rich after hardening. Photo: Kristin Balksten.

Both kinds of lime in the Uddevalla find were grainy and stiff when found, but it was possible to whip them. As the lime was experimentally whipped it also became more runny, suggesting to us that it might still be possible to use it. In order to try out its properties as a binder, mortar samples were taken from each type, see table 1. A direct comparison can be made between our samples and earth slaked and wet slaked Gotlandic lime, which are described more completely in Traditional lime mortar and plaster (Balksten 2007).

can inform how much of the lime that is active as a binder. The white lime of barrel 1 still contains a more active binder than the grey lime of barrel 4. The difference is also visible as the white lime is a fat type and the grey lime is a lean type, just as described by Siöbladh & Engeström (1750). This find can contribute to the understanding of historic mortars that sometimes seem extremely fat in analysis (ex. Balksten 2010; Persson 2010; Balksten et al. 2013). It suggests to us that fat mortars were simply produced by lime that was slaked to be putty and then stored for a longer time before being used in mortar, with the effect that the hydraulic components acted as aggregate rather than binder.

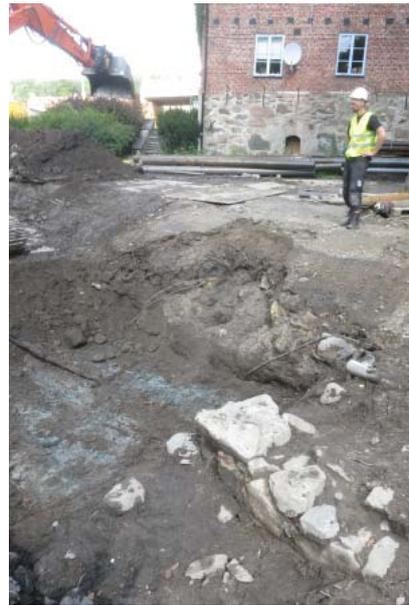
*Figure 10. Parts of the wall in the 2014 trench with Hasselbackshuset in the background. The latter was built in 1814 and is one of the oldest standing houses in Uddevalla today. Mortar samples from the wall in the trench and the still standing house have been analysed in this study.*

In an attempt to corroborate or refute such a hypothesis, additional chemical analyses were made of mortar from both the still standing Hasselbackshuset and the wall in the 2014 trench. The samples from the documented wall were both very similar, probably a sub-

hydraulic lime of the same kind as in the barrels. A sample from the mortar between the granite footings of Hasselbackshuset was quite similar to these both. Finally, the mortar from between the bricks in the same house was clearly different, a feebly hydraulic lime with a mixing ratio different from the others (Brorsson 2015). It can be concluded that the lime putties and mortars evidently belong to the same tradition.
