# Trade and use of building lime

- early 19<sup>th</sup>-century lime barrels from an excavation in  
Uddevalla, Bohuslän

*Niklas Ytterberg & Kristin Balksten*

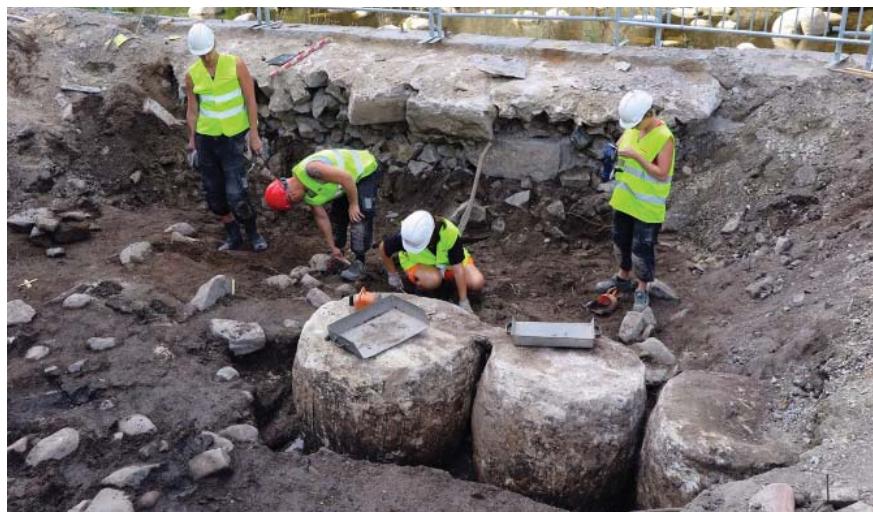
Figure 3a. Photo of the lime barrels (from the left) 4, 3 and 2, which were excavated during the summer of 2014. They have differing sizes but seem to hold similar lime putties. Photo: Kristin Balksten.

In order to gain a better understanding of how the lime putty was prepared and treated, a more detailed description of the barrels is required. The biggest barrel, to the north-west, measured 1.15 m in maximum width, and the second biggest, at the end of the row to the south-east, measured around 1 m. The two barrels in the middle were slightly smaller, c. 0.8 m. The height differed from c. 0.8 to 1 m, making the barrels a bit wider than they were high. The barrels were bulged slightly in the middle, as usual. The staves were very poorly preserved. Impressions of the staves in the lime putty revealed an individual width of 0.10 - 0.15 m (4 to 6 inches) and a thickness of about 25 mm (1 inch). Preserved fragments of hoops indicate that they appear to be made of birch, whereas the bases of the barrels are made of pine. No head or lids are preserved, but these may very well never have been present. Three of the barrels contained a more greyish, lumpy lime and one barrel a distinctly white, creamy lime. We saw quite a lot of lime lumps in the pit, especially in the top fill close to the barrels' mouths. A probable explanation for this is that quicklime spilled over in the process of tipping it from smaller barrels to these ground-fixed barrels.

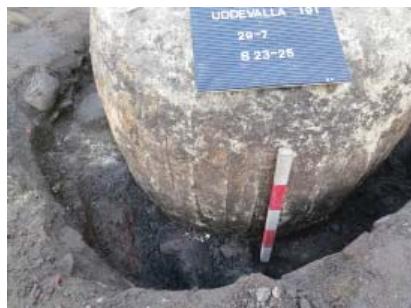
Figure 3b. Close-up of lime barrel 3 with the individual birch staves clearly visible. Photo: Niklas Ytterberg.

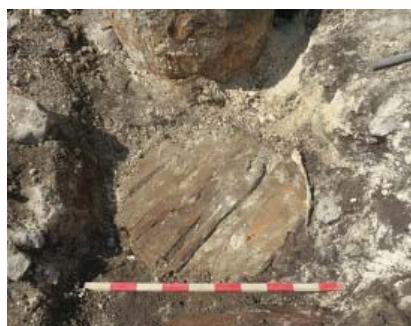
Figure 3c. Photo of the base of barrel 4, made of pine. Photo: Veronica Forsblom Ljungdahl.
