Trade and use of building lime

- early 19th-century lime barrels from an excavation in
Uddevalla, Bohuslän

Niklas Ytterberg & Kristin Balksten

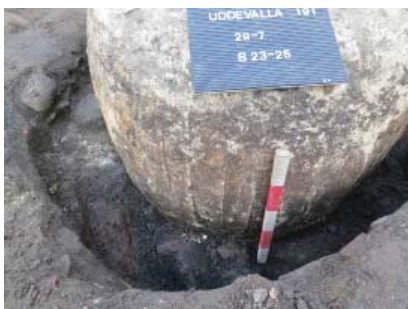
Figure 3b. Close-up of lime barrel 3 with the individual birch staves clearly visible. Photo: Niklas Ytterberg.

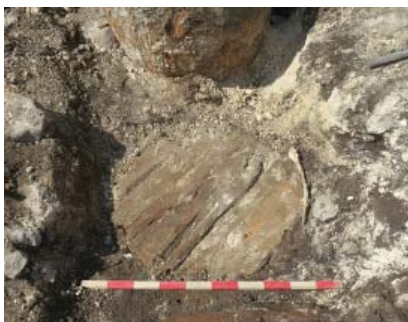
Figure 3c. Photo of the base of barrel 4, made of pine. Photo: Veronica Forsblom Ljungdahl.
