Trade and use of building lime

- early 19th-century lime barrels from an excavation in
Uddevalla, Bohuslän

Niklas Ytterberg & Kristin Balksten

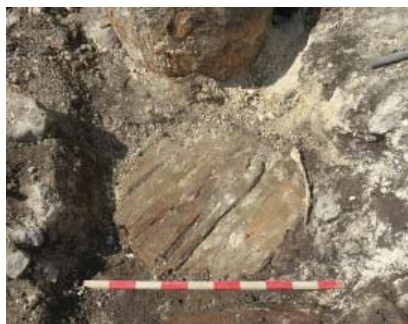
Figure 3c. Photo of the base of barrel 4, made of pine. Photo: Veronica Forsblom Ljungdahl.

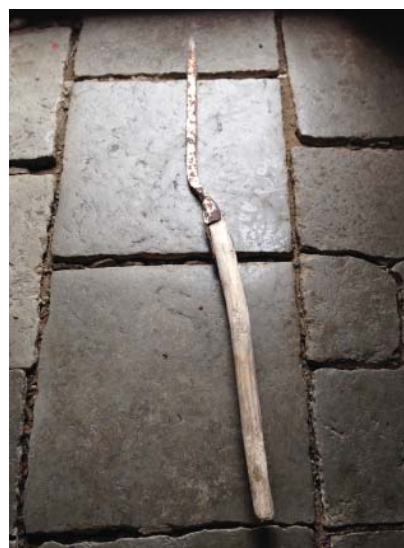
Figure 4. Lime whip from Svenneby old church. Photo: Kristin Balksten.

be recognized by the specific lime lumps in historic mortars (Balksten 2010). To be able to use earth slaked lime as a binder it must first be beaten with a lime whip (Siöbladh & Engeström 1750; Hidemark & Holmström 1984, p. 12pp).

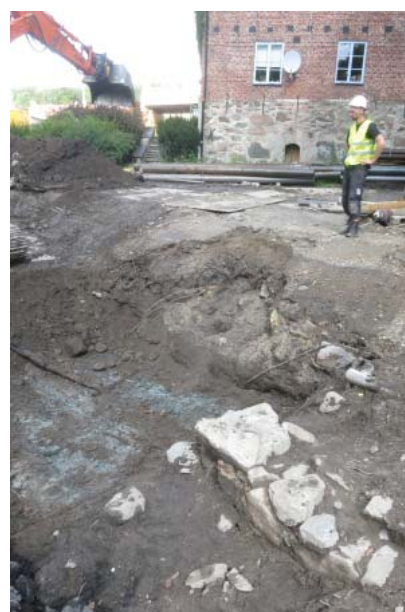
Figure 10. Parts of the wall in the 2014 trench with Hasselbackshuset in the background. The latter was built in 1814 and is one of the oldest standing houses in Uddevalla today. Mortar samples from the wall in the trench and the still standing house have been analysed in this study.

In an attempt to corroborate or refute such a hypothesis, additional chemical analyses were made of mortar from both the still standing Hasselbackshuset and the wall in the 2014 trench. The samples from the documented wall were both very similar, probably a sub-

hydraulic lime of the same kind as in the barrels. A sample from the mortar between the granite footings of Hasselbackshuset was quite similar to these both. Finally, the mortar from between the bricks in the same house was clearly different, a feebly hydraulic lime with a mixing ratio different from the others (Brorsson 2015). It can be concluded that the lime putties and mortars evidently belong to the same tradition.
