Trade and use of building lime

- early 19th-century lime barrels from an excavation in
Uddevalla, Bohuslän

Niklas Ytterberg & Kristin Balksten

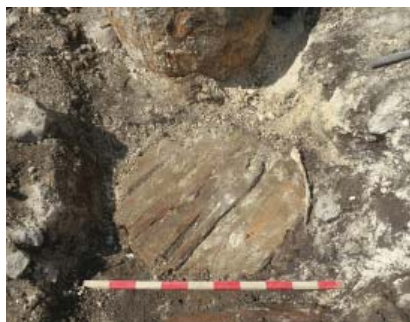
Figure 3c. Photo of the base of barrel 4, made of pine. Photo: Veronica Forsblom Ljungdahl.
