Dirt, dung and sanitation in the medieval Turku

- (Mis)Conceptions of medieval sanitation

Liisa Seppänen

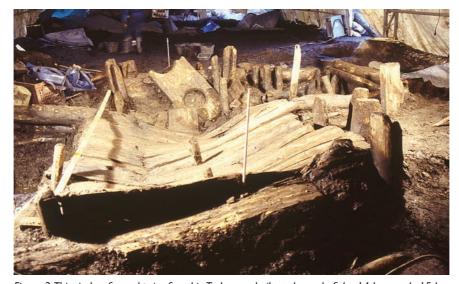
Figure 3.This timber framed privy found in Turku was built at the end of the 14th or early 15th century. The size of the privy was c. 5 m2 and it contained a seat meant at least for two people. The privy was probably emptied prior to its abandonment at the end of the Middle Ages since the soil inside did not contain manure (Seppänen 2012b, p. 432, original photo: The Museum Centre of Turku).

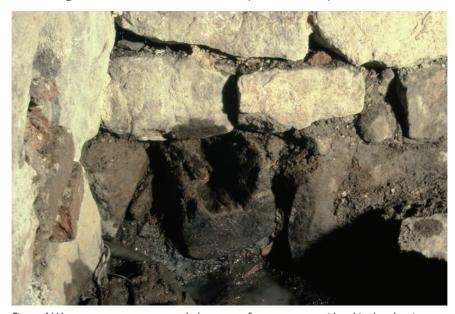
Figure 4. Wastewater management and placement of sewers was considered in the planning and construction of buildings, too. A masonry building from the 15th century was provided with a timber sewer leading the waters to the gutter of the adjacent street (Seppänen 2012b, p. 882, original photo:The Aboa Vetus & Ars Nova Museum, Turku).

In Turku, the sewers have been found in connection with the buildings (under and on the floors as well as underneath the walls), next to the buildings and plot borders as well as on the streets and yards (Fig. 4) The majority of the sewers were lined with planks or timber, but some sewers were lined with birch barks, branches, sticks, stones and even bricks. Some of the sewers were clearly related to handicrafts and activities, which needed lots of water like tanning, shoemaking and dying. Consequently, the sewers can be considered not only as the evidence of sanitation but also as an indicator of occupational distribution in the town area (Seppänen 2012b, p. 879-881).

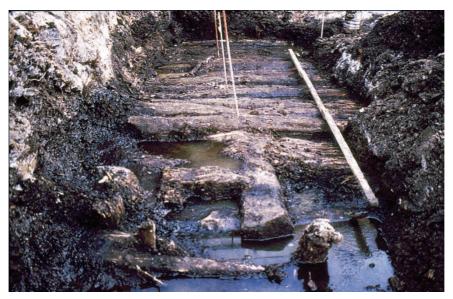
Figure 5. According to the present knowledge, the first streets with timber pavement were made in the 1370s in Mätäjärvi quarter (Seppänen 2012b, p. 461, original photo: The Museum Centre of Turku.).

The first streets with wooden pavements were made in Turku in the 1370s and 1380s when the town expanded into new areas (Fig. 5). Interestingly, it seems that in this phase, only the new streets were paved with timber while the older ones remained unpaved until the early 15th century. In the next phase, the streets were paved with stones. This seems to have taken place after a big fire in 1429 and when large parts of the town were reconstructed. Again, the oldest evidence of stone paved streets comes from the outskirts of the town and not in the centre. However, the lack of evidence can be explained by the possible reuse of stones when making a new surface. The removal of stones could only be detected when the surfaces are exposed with care and by documentation and analysis in detail. By the early 16th century, all streets in

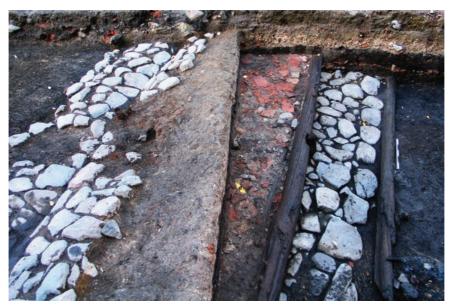
Fig. 7.The photo presents the stratigraphy of different pavements and phases of the School Square. In the oldest phase (on right), the square was provided with a stone paved lane framed with logs. In the next phase (middle), the lane was paved with bricks while the square remained unpaved. The square was paved with stones in the late 15th century or in the early 16th century (left). Photo: Päivi Repo.
