# Dirt, dung and sanitation in the medieval Turku

- (Mis)Conceptions of medieval sanitation

*Liisa Seppänen*

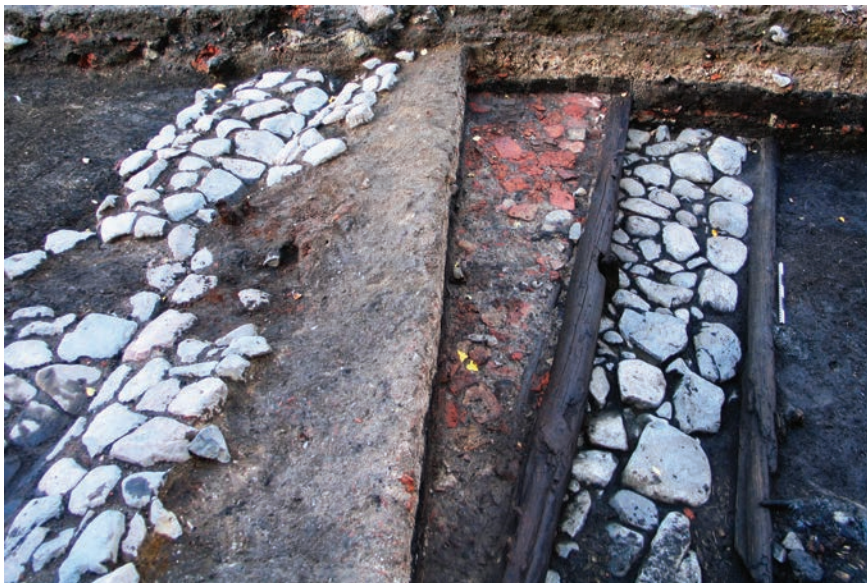
*Fig. 7. The photo presents the stratigraphy of different pavements and phases of the School Square. In the oldest phase (on right), the square was provided with a stone paved lane framed with logs. In the next phase (middle), the lane was paved with bricks while the square remained unpaved. The square was paved with stones in the late 15th century or in the early 16th century (left). Photo: Päivi Repo.*
