Trade and use of building lime

- early 19th-century lime barrels from an excavation in
Uddevalla, Bohuslän

Niklas Ytterberg & Kristin Balksten

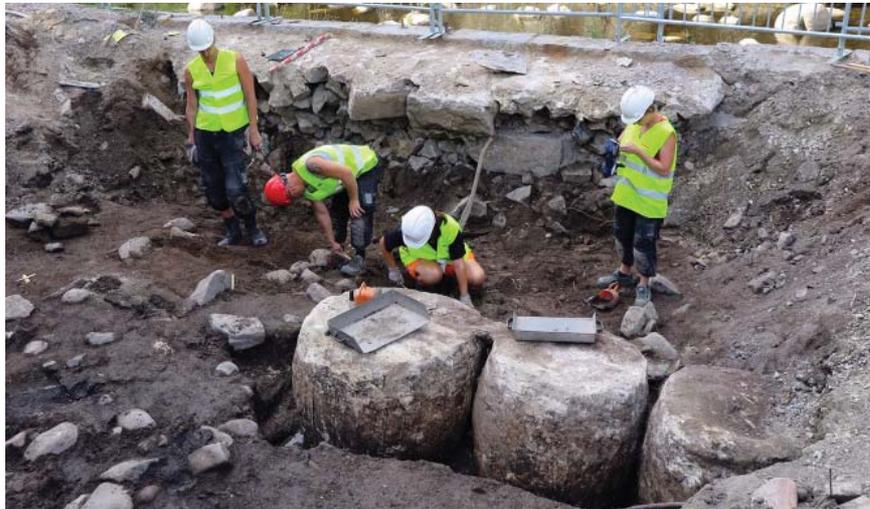
Figure 3a. Photo of the lime barrels (from the left) 4, 3 and 2, which were excavated during the summer of 2014. They have differing sizes but seem to hold similar lime putties. Photo: Kristin Balksten.

The four large barrels full of lime putty were placed in a large pit, 4.7 by 1.6 metres wide and approximately 1 metre deep. The fill consisted of redeposited 17th and 18th century material from truncated earlier deposits, the most recent finds dating to c. 1770. On top of the barrels there were traces of a cover, consisting of at least ten slats of small dimensions, along with some nails. Directly on top of the cover we found significant amounts of

In order to gain a better understanding of how the lime putty was prepared and treated, a more detailed description of the barrels is required. The biggest barrel, to the north-west, measured 1.15 m in maximum width, and the second biggest, at the end of the row to the south-east, measured around 1 m. The two barrels in the middle were slightly smaller, c. 0.8 m. The height differed from c. 0.8 to 1 m, making the barrels a bit wider than they were high. The barrels were bulged slightly in the middle, as usual. The staves were very poorly preserved. Impressions of the staves in the lime putty revealed an individual width of 0.10 - 0.15 m (4 to 6 inches) and a thickness of about 25 mm (1 inch). Preserved fragments of hoops indicate that they appear to be made of birch, whereas the bases of the barrels are made of pine. No head or lids are preserved, but these may very well never have been present. Three of the barrels contained a more greyish, lumpy lime and one barrel a distinctly white, creamy lime. We saw quite a lot of lime lumps in the pit, especially in the top fill close to the barrels' mouths. A probable explanation for this is that quicklime spilled over in the process of tipping it from smaller barrels to these ground-fixed barrels.

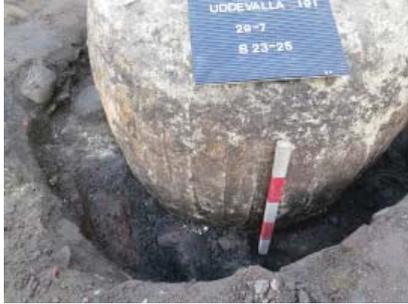
Figure 3b. Close-up of lime barrel 3 with the individual birch staves clearly visible. Photo: Niklas Ytterberg.

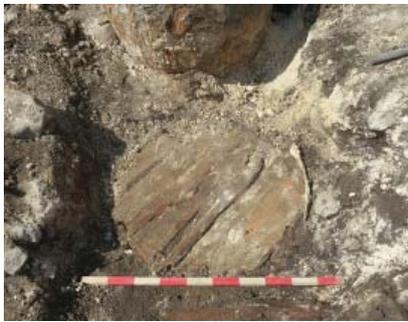
Figure 3c. Photo of the base of barrel 4, made of pine. Photo: Veronica Forsblom Ljungdahl.

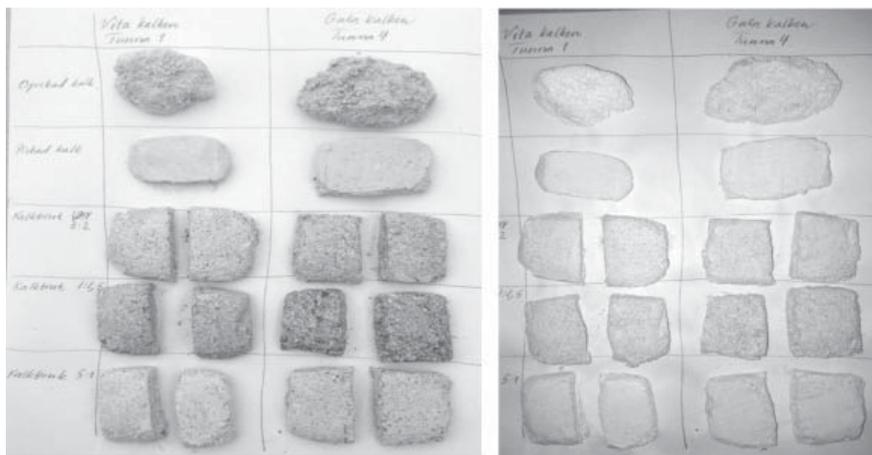
Figure 5. The experimental samples when they are fresh (to the left) and after two weeks (to the right), when they have been dried white. The samples that seemed very lean as fresh appeared more lime rich after hardening. Photo: Kristin Balksten.
