# Trade and use of building lime

- early 19<sup>th</sup>-century lime barrels from an excavation in  
Uddevalla, Bohuslän

*Niklas Ytterberg & Kristin Balksten*

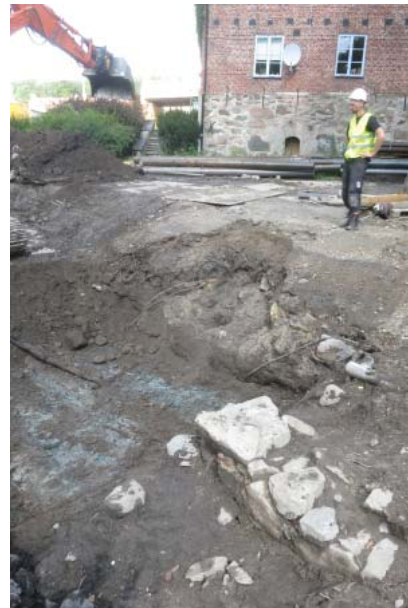
*Figure 10. Parts of the wall in the 2014 trench with Hasselbackshuset in the background. The latter was built in 1814 and is one of the oldest standing houses in Uddevalla today. Mortar samples from the wall in the trench and the still standing house have been analysed in this study.*

In an attempt to corroborate or refute such a hypothesis, additional chemical analyses were made of mortar from both the still standing Hasselbackshuset and the wall in the 2014 trench. The samples from the documented wall were both very similar, probably a sub-

hydraulic lime of the same kind as in the barrels. A sample from the mortar between the granite footings of Hasselbackshuset was quite similar to these both. Finally, the mortar from between the bricks in the same house was clearly different, a feebly hydraulic lime with a mixing ratio different from the others (Brorsson 2015). It can be concluded that the lime putties and mortars evidently belong to the same tradition.
