Trade and use of building lime

- early 19th-century lime barrels from an excavation in
Uddevalla, Bohuslän

Niklas Ytterberg & Kristin Balksten

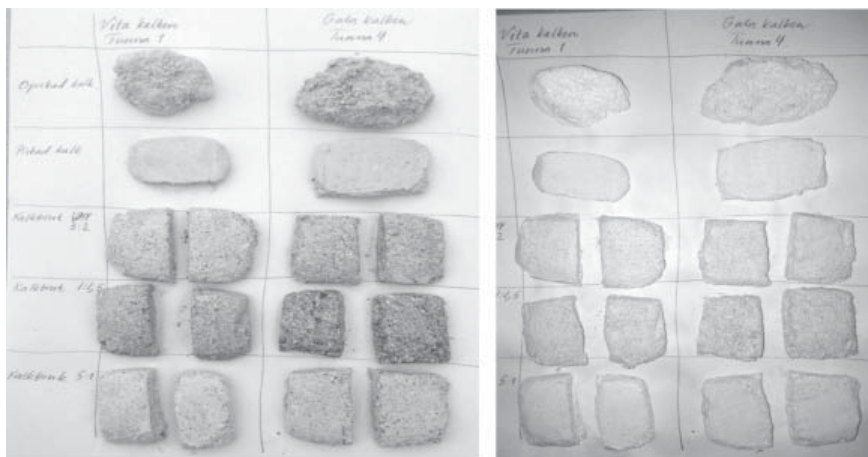
Figure 5. The experimental samples when they are fresh (to the left) and after two weeks (to the right), when they have been dried white. The samples that seemed very lean as fresh appeared more lime rich after hardening. Photo: Kristin Balksten.
