Dirt, dung and sanitation in the medieval Turku

- (Mis)Conceptions of medieval sanitation

Liisa Seppänen

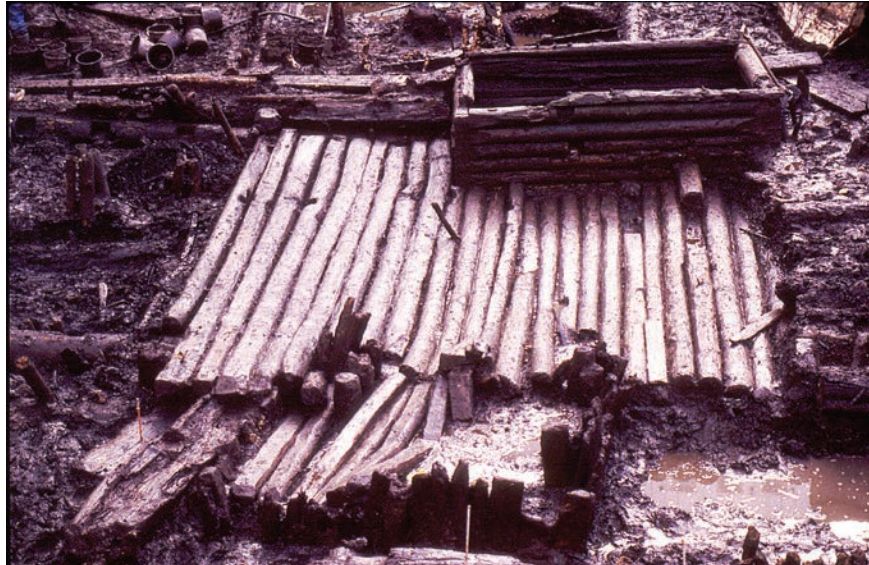
Figure 6. In Mätäjärvi quarter, a yard between two buildings was carefully paved with logs in the 1400s. The pavement covered an area of 43 m² (Seppänen 2012b, p. 359–365, original photo: The Museum Centre of Turku.).

It seems that as soon as Turku was inhabited some of the passages and yards were covered with planks and timber to facilitate walking and transportation. The more systematic paving of yards took place at the end of the 14th century following the paving of the streets (Seppänen 2012b, p. 882–883). In Novgorod, which is famous for its well-preserved yard pavements, the first pavements were made more carefully and with more laborious techniques (Khoroshev & Sorokin 1992, p. 55). In Turku we have not been able to make this kind of conclusion. In the early 15th century, however, the wooden pavements were made with utmost care and with a good quality

of timber. This matches well with the time when the town started to flourish and develop in many different ways (Fig. 6).
